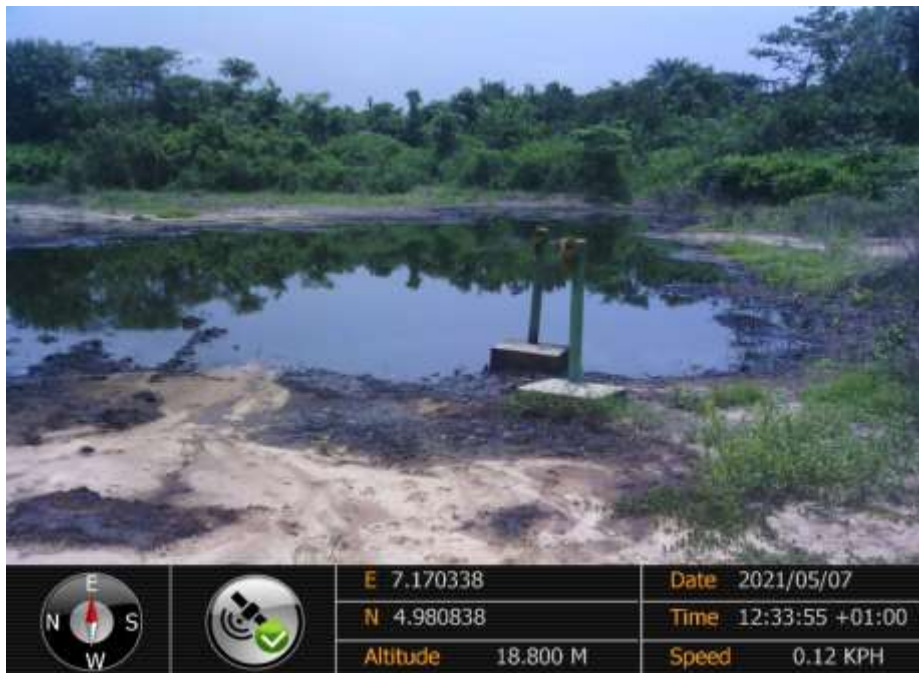
Overview: Part of spill impact on 12inch Imo River 2 – Ogale Pipeline at Odagwa. Picture was taken during Joint Investigation of 7<sup>th</sup> May 2021.

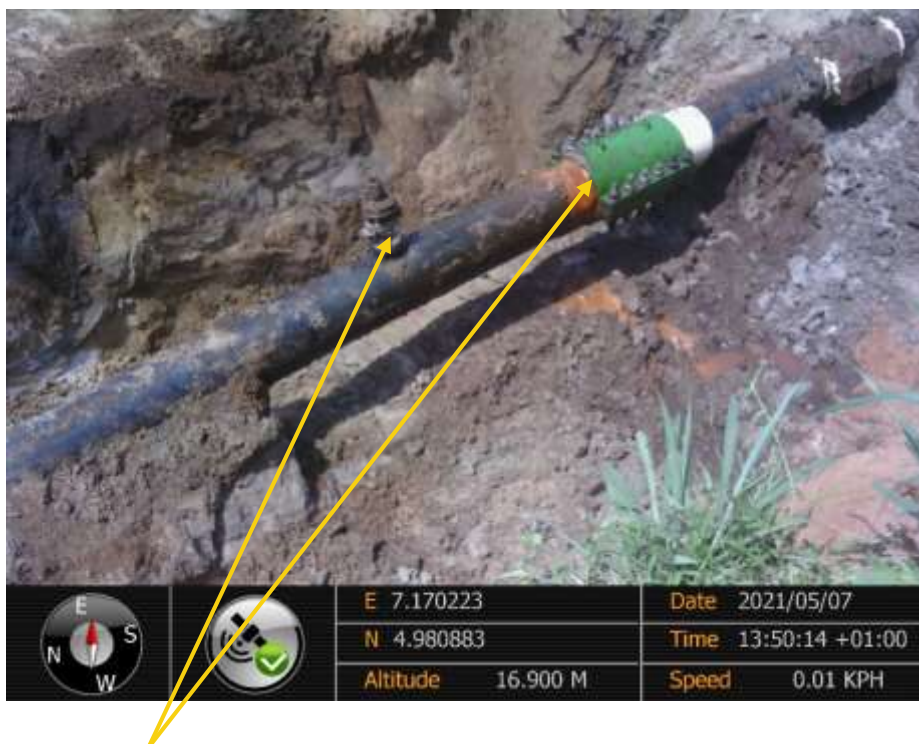
Close-up: Third Party tampering with clamp. Also 1.5m distance from the clamp is a newly installed 2inch non leaking ball valve at 12 o'clock position on 12inch Imo River 2 – Ogale Pipeline at Odagwa. Picture was taken during Joint Investigation of 7<sup>th</sup> May 2021.
