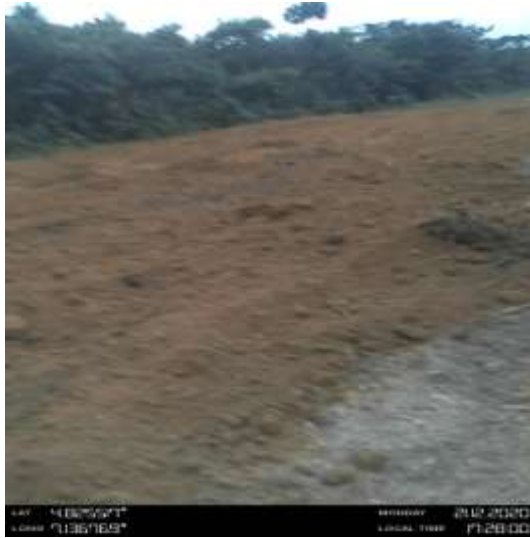
Overview: Part of spill impact on 36'' Nkpoku Ogale Pipeline at Agbonchia.  
Picture was taken during Joint Investigation on 21st Dec 2020.

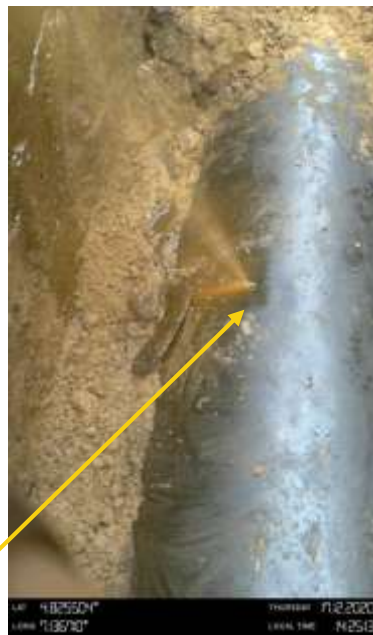
Close-up 1: Rectangular hole of 12mmx15mm created 10 o'clock position on 36inch Nkpoku Ogale Pipeline at Agbonchia. Picture was taken during Joint Investigation on 21st Dec 2020.
