Overview: Part of spill impact on 28" Nkpoku Bomu Pipeline at Rumuewhara. Picture was taken during Joint Investigation of 26th March 2020.

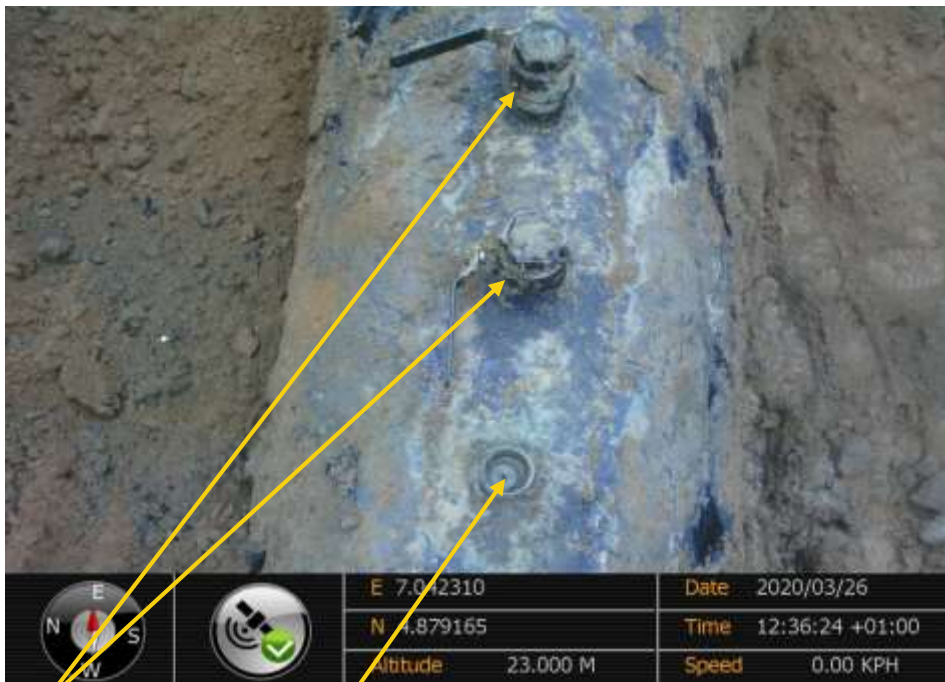
Close-up: 2nos 2" ball valves and 1 no 1" nipple installed at 12 o'clock position on 28" Nkpoku Bomu Pipeline at Rumuewhara. Picture was taken during Joint Investigation of 26th March 2020.
